TECHNICAL BULLETIN # SRF 07-01

Re: Bent Arm on Left Rear

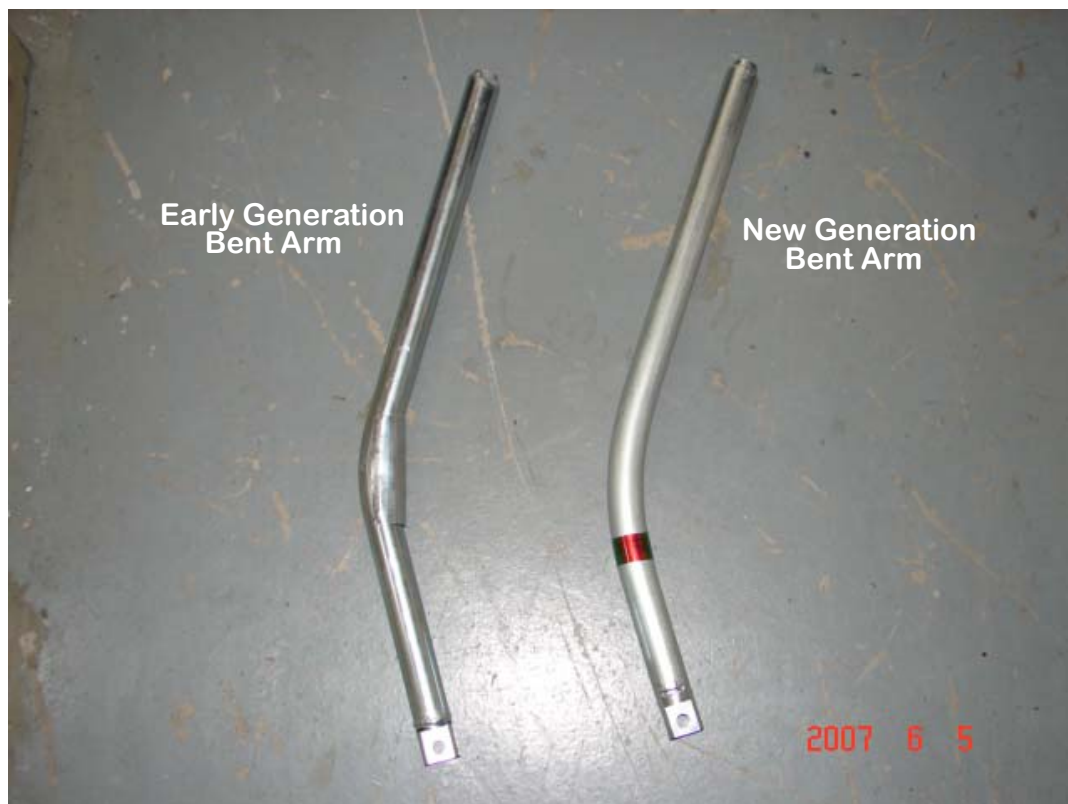
It has come to our attention that some of you may not have been aware of the change made several years ago to the "Bent Arm" on the left rear (forward half of lower control arm). The early ones had a reinforcement gusset in the bent area. The gusset was either welded on the top and bottom only or they were welded all the way around. The fully welded parts have been prone to cracking / breakage and the top and bottom welded parts (see below) can bend; in fact if the arm is rubbing your tire, it has already bent!

This Bulletin is to remind everyone that there has been a newer generation for several years that has no gusset and is made from heavier wall tubing. It was recommended some time ago that everyone upgrade to the newer generation Bent Arm; and we are reissuing this statement to reduce the chance that this is not fully known in the community.
